**Test Report No:** 178114-R

**SUBJECT:** Testing Flammability to UL 1715, Fire Test of Interior Finish Material.

**SAMPLE ID:** Client refers to samples received as "SONEX Classic Colortec (COC-2)". Twenty-Four (24) samples of 2 x 4 ft material were used during the testing procedure. These samples were received on 6/2/99 in good condition from the client.

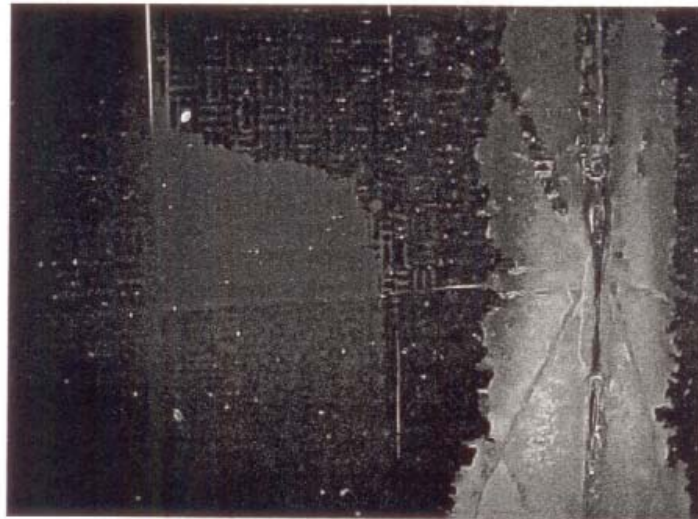
PHOTO 4. Corner after Test

Flaming nor charring did not extend to the extremities of the sample material. Damage diminishes at increasing distance from the immediate fire exposure area.
