ACOUSTICAL PERFORMANCE TEST REPORT

TYPE: Dual Window System Consisting of Three Vinyl Clad Wood Casement Windows Mullered Together with the Magnetic Seal Interior Storm Window System

Report No:	01-46458.01
Test Date:	07/31/03
Report Date:	09/26/03
Expiration Date:	07/31/07

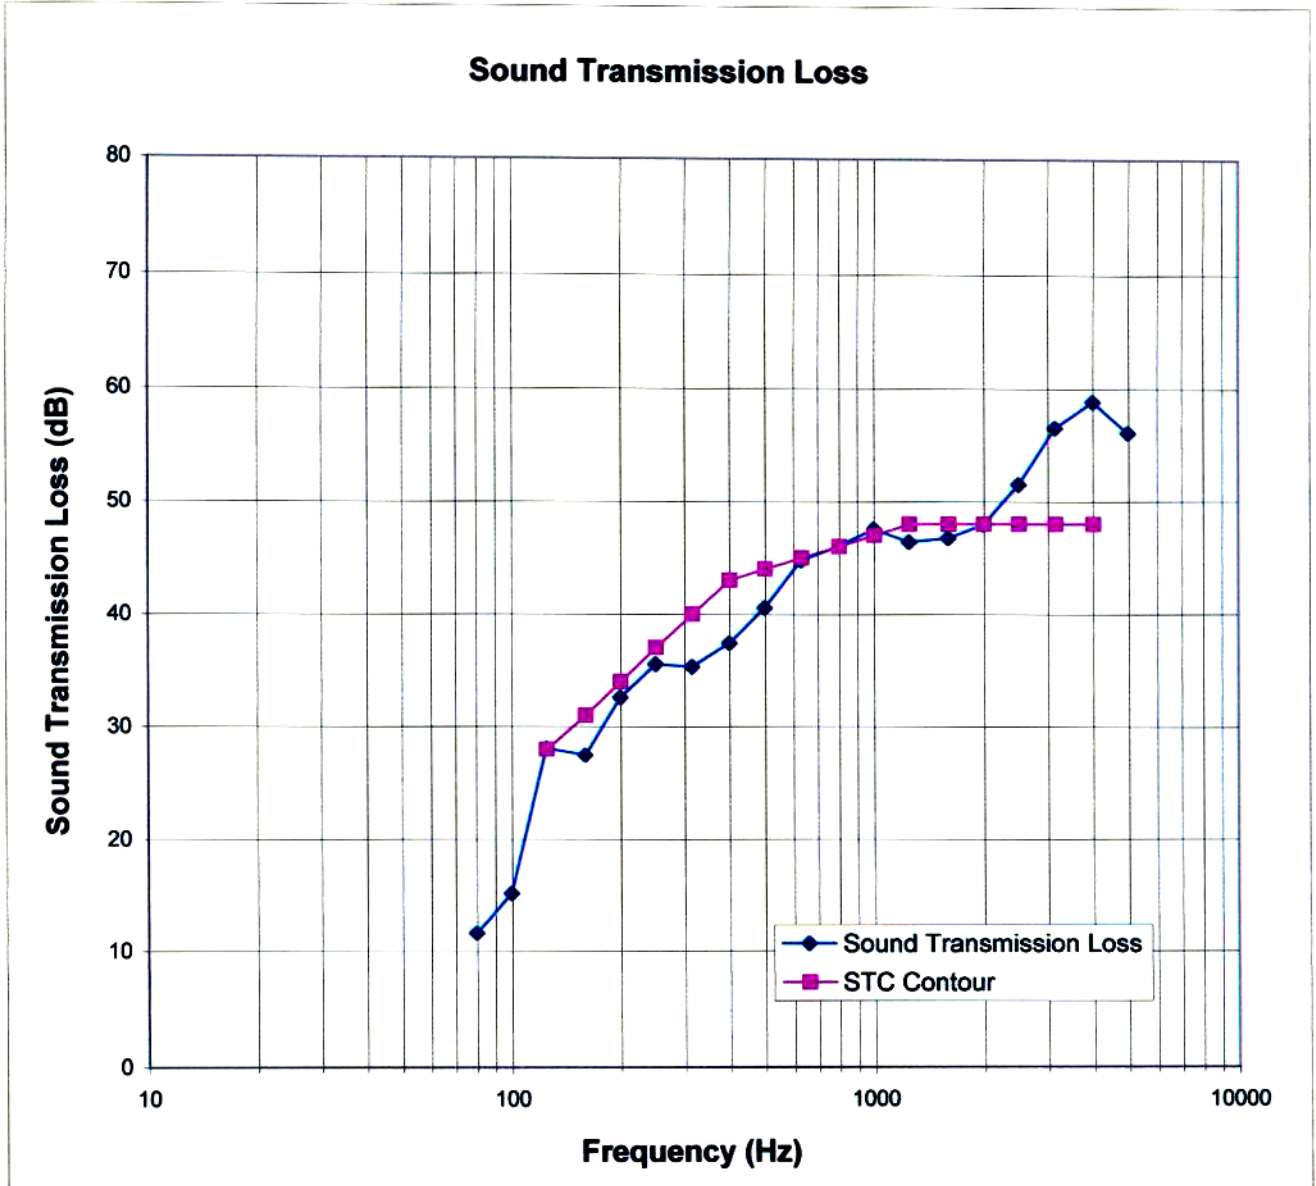
STC Rating 44 *(Sound Transmission Class)*
Deficiencies 23 *(Number of deficiencies versus contour curve)*
OITC Rating 28 *(Outdoor/Indoor Transmission Class)*

Specimen Clad Casement Window, in jamb storm window, 3 individual lites

ATI No.	01-46458.01B	Date	07/31/03
Client	Climate Seal™		
Specimen	Clad Casement Window, in jamb storm window, 3 individual lites		
Specimen Area	20.63 Sq Ft		
Filler Area	119.37 Sq Ft		
Operator	Todd Kister

Freq (Hz)	Bkgrd SPL (dB)	Absorp (Sabines /Sq Ft)	Source SPL (dB)	Receive SPL (dB)	Filler TL (dB)	Specimen TL (dB)	95% Conf Limit	No. of Deficiencies	Trans Coef Diff
80	38.9	54.7	83.9	68.1	36.4	12	2.21	0	17.2
100	40.6	61.4	87.1	67.2	40.3	15	2.81	0	17.5
125	40.5	46.5	91.9	60.5	47.4	28	2.27	0	12.0
160	42.6	44.7	95.6	65.0	47.7	27	1.08	4	12.8
200	45.6	46.2	100.6	64.7	53.2	33	0.56	1	13.3
250	42.1	47.7	102.7	63.7	57.9	36	1.11	1	14.9
315	39.4	46.2	101.1	62.3	63.2	35	0.46	5	20.3
400	34.2	49.5	99.9	58.7	67.6	37	0.46	6	22.6
500	28.8	49.7	99.7	55.3	69.6	41	0.42	3	21.4
630	22.6	52.5	103.8	55.0	71.7	45	0.29	0	19.3
800	23.1	56.2	105.7	55.3	70.3	46	0.31	0	16.7
1000	21.3	59.3	105.8	53.7	77.4	48	0.32	0	22.2
1250	21.2	66.3	106.6	55.1	83.6	46	0.26	2	29.6
1600	15.3	70.1	111.3	59.2	86.5	47	0.23	1	32.2
2000	10.3	75.5	108.8	55.2	87.0	48	0.23	0	31.4
2500	6.6	88.3	107.4	49.6	85.7	52	0.34	0	26.5
3150	6.3	108.2	107.5	43.8	86.5	57	0.26	0	22.4

4000	6.7	126.6	106.8	40.1	85.6	59	0.48	0	19.2
5000	7.6	162.1	105.1	40.1	83.0	56	0.62	0	19.3
