## ACOUSTIC SYSTEMS ACOUSTICAL RESEARCH FACILITY OFFICIAL LABORATORY REPORT AS-TL1765

**Subject: Sound Transmission Loss Test**

**Asymmetrical Staggered Metal Stud Wall Assembly w/Two Layers 5/8" FIRECODE Gypsum (Source Side), One Layer 5/8" FIRECODE Gypsum on RC-1 Channels (Receive Side), and R-19 Ultra Touch Blue Insulation**

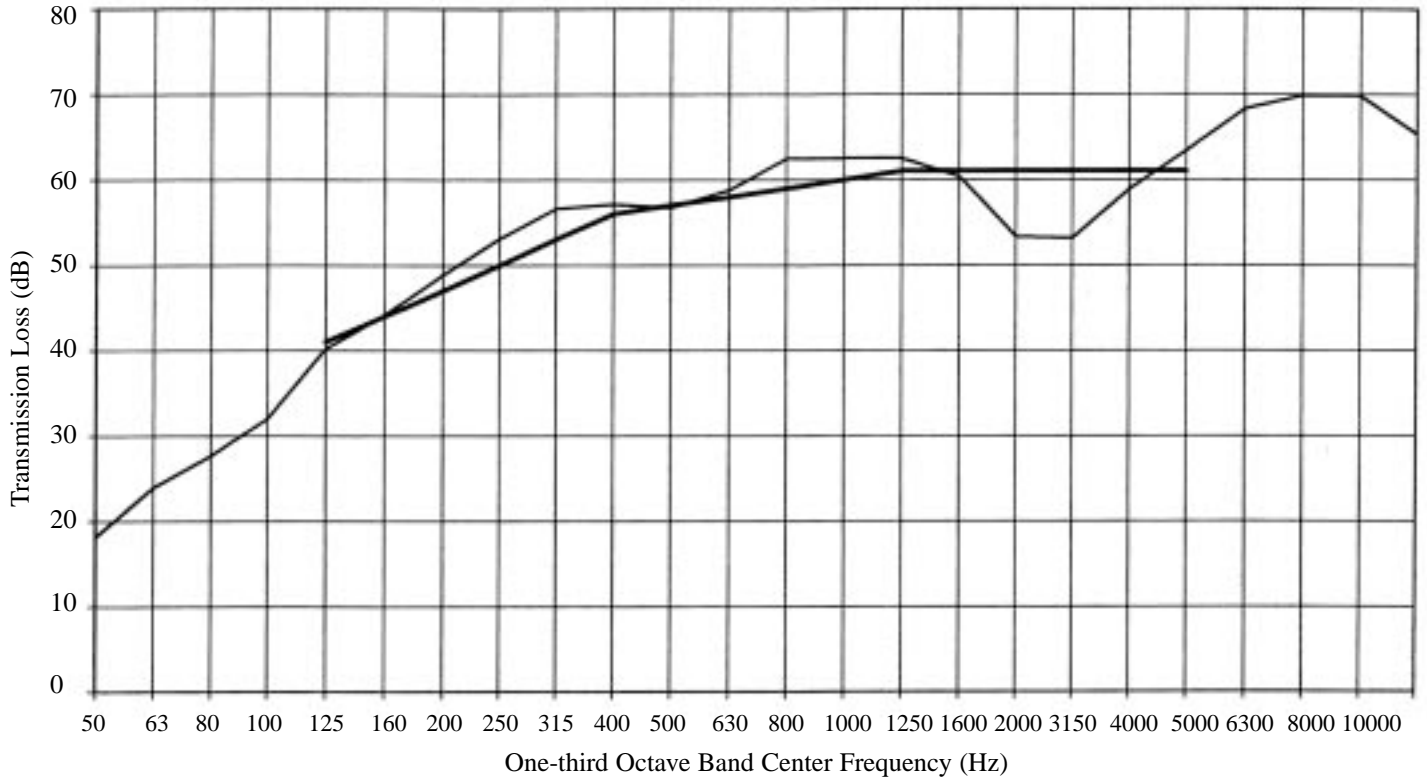
**Asymmetrical Staggered Metal Stud Wall Assembly w/Two Layers 5/8"  
FIRECODE Gypsum (Source Side), One Layer 5/8" FIRECODE Gypsum on RC-1 Channels  
(Receive Side), and R-19 UltraTouch Blue Insulation  
AS-TL1765, STC 57 OITC 44**

The Sound Transmission Loss of the test specimen at the preferred one-third octave band center frequencies is tabulated below and then presented graphically. Octave-band Transmission Loss values are calculated as described in Section 12.4 of ASTM E90-97.

1/3 Octave Band Center Freq. (Hz)	Transmission Loss (dB)	Uncertainty (+/-dB)	NOTES	Octave Band TL (dB)	STC Deficiencies
50	18		[g]		
63	24		[d] [g]	22	
80	28	1.8	[g]		
100	32	1.8	[d]		
125	40	2.6	[d]	36	1
160	44	1.5	[d]		
200	49	0.7	[d]		
250	53	1.0	[d]	52	
315	57	0.6	[d]		
400	57	0.6			
500	57	0.5		57	
630	59	0.4			
800	62	0.4			
1000	63	0.4	[c]	62	
1250	63	0.3	[c]		
1600	60	0.2	[c]		1
2000	53	0.3		55	8
2500	53	0.3			8
3150	59	0.2	[c]		2
4000	63	0.2	[c]	62	
5000	68	0.3	[c]		
6300	70	0.4	[a] [c]		
8000	70	0.5	[a] [c]	68	
10000	65	0.8	[a]		
<b>STC</b>	<b>57</b>				
<b>OITC</b>	<b>44</b>
