**B-3451.1**

**Measurement of the Airborne Sound  
Transmission Loss of  
One (1) Wall Assemblies**

# Airborne Sound Transmission Loss Measurement Performed on One Wall Assembly for NGC Testing Services

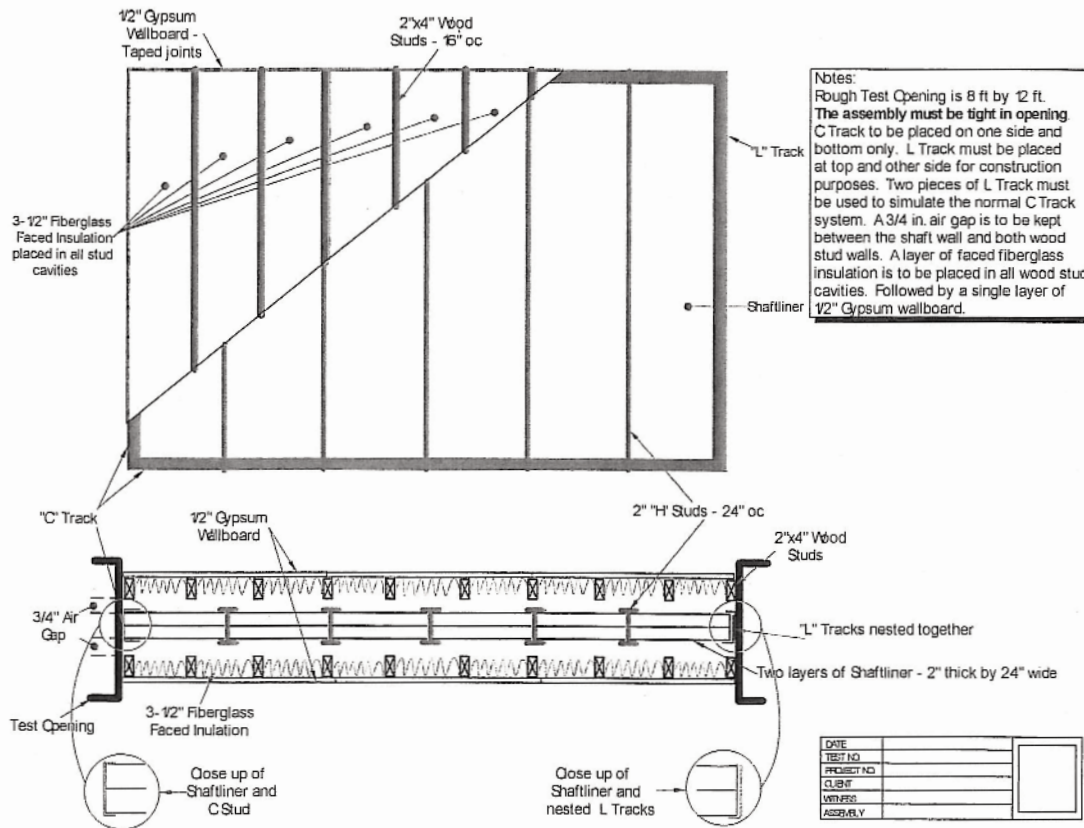
The wall assembly had two layers of shaftliner between two rows of wood studs; on each exterior face was a layer of gypsum board. Two layers of shaftliner each composed of 6 panels 25 x 610 x 2440 mm, were installed vertically with H channels in between the panels. The C track was installed at the bottom and on one side of the panels and two pieces of L track installed nested together at the top and one side of the panels to simulate C track in this special installation. On both sides, an air space of 19 mm was left between the shaftliner layer and the row of 38 x 89 mm wood studs, spaced at 406 mm on center. The 89 mm thick, R12 glass fibre batts were installed in the cavities of the two row of wood studs. The 13 mm thick laminated gypsum boards identified by the client as "National Gypsum SoundBreak® Wallboard" were attached vertically to the wood studs with 41 mm long, type S drywall screws spaced at 610 on center along the edge and in the field. All the laminated gypsum board joints were caulked and covered with a metal tape.

B3451-1W: Drawing received from client of wall assembly to be built

Element	Actual Thickness (mm)	Surface weight (kg/m <sup>2</sup> )	Mass (kg)
Laminated Gypsum Board		13.27	118.4
Glass Fibre Batts		0.87	7.8
Wood Studs		5.78	51.6
Air			
Shaftliner including track		39.06	348.4
Air			
Wood Studs		5.93	52.9
Glass Fibre Batts		0.86	7.7
Laminated Gypsum Board		13.35	119.1
<b>Total</b>	<b>244</b>		<b>705.9</b>

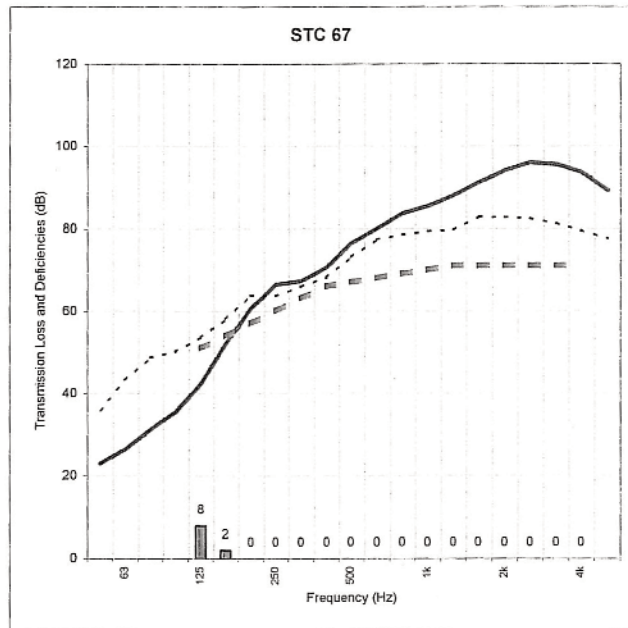
**In the graph:**

Solid line is the measured sound transmission loss for this specimen. Dashed line is the STC contour fitted to the measured values according to ASTM E413-04. The dotted line is 10 dB below the flanking limit established for this facility. For any frequency where measured transmission loss is above the dotted line, the reported value is potentially limited by vibration transmission via laboratory surfaces, and the true value may be higher than that measured.

Bars at bottom of graph show deficiencies. At each frequency the difference between the shifted reference contour value and the measured data is calculated. Only deficiencies, that is, where the measured data are less than the reference contour, are counted in the fitting procedure for the STC, defined in ASTM E413.

Frequency (Hz)	Airborne Sound Transmission Loss (dB)	95% Confidence Limits
50	23 *	
63	27	
80	31	± 5.0
100	36	± 4.7
125	43	± 2.6
160	52	± 1.7
200	61	± 0.9
250	66 c	± 0.9
315	67	± 0.9
400	71	± 0.9
500	77	± 0.7
630	80 c	± 0.5
800	84 c	± 0.5
1000	86 *	± 0.4
1250	88 *	± 0.4
1600	91 *	± 0.3
2000	94 *	± 0.3
2500	96 *	± 0.4
3150	96 *	± 0.5
4000	94 *	± 0.5
5000	89 *	± 0.5
Sound Transmission Class (STC) = 67

**Note:** At most frequencies, the measured sound transmission loss for this specimen is above the threshold for limiting transmission loss established for flanking (structure-borne) transmission via facility surfaces. Hence the reported values for bands above 200 Hz provide an estimate of the lower limit of airborne sound transmission loss for the specimen. However, this does not affect the bands controlling the STC rating.
