REPORT OF TEST

Test Procedure: UL 1715 – Fire Test of Interior Finish Material

SUBJECT: Testing Flammability to UL 1715, Fire Test of Interior Finish Material.

SAMPLE ID: Client refers to samples received as "Sonex One". Our client Purchase Order #8824, for reference. Twenty-four samples of 2 x 4 ft. material were used during the testing procedure. These samples were received on 6/2/99 in good condition from the client.

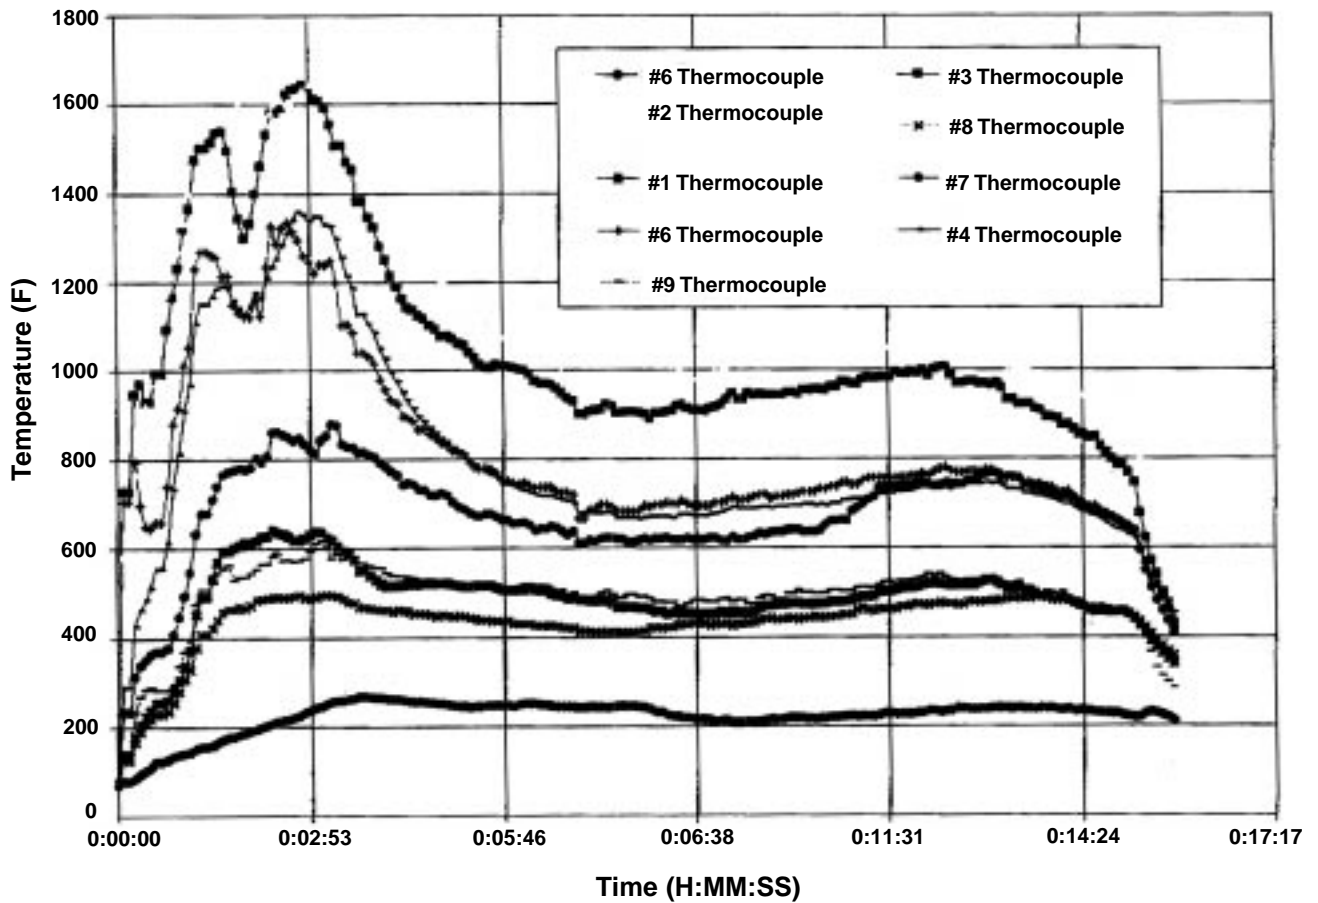
Temperature Vs. Time
Rendered by Manufacturer for: Acoustical Surfaces Inc.
Job#: 126659
Date 6/24/99 Procedure: UL 1715

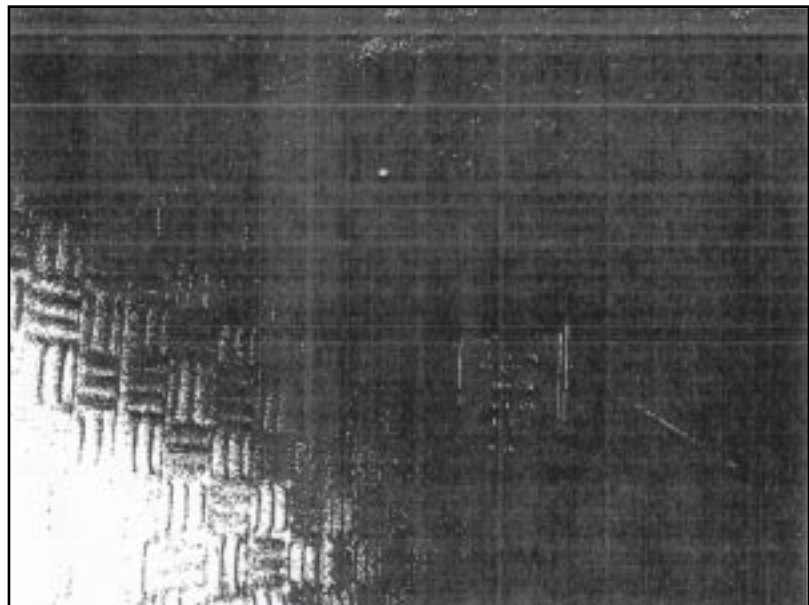
PHOTOS 4. 12 ft. Wall Charring

Measurements of Charring: *(See photos 3, 4)*

- Along 12 ft. wall – 6 ft. 3 in.
- Along 8 ft. wall – 6 ft. 7 in.
- Diagonal across ceiling (from corner) – 5 ft. 7 in.

Flaming was not seen along the ceiling edges joining the wall sections. The charring of the material was viewed as an effect of the extreme temperature experienced in the test room. All measurements of charring were taken at the farthest visible charred location. The temperature estimated for charring of the material is approximately 650 °F to 700 °F.
